Independent Property Inspection Consultants Property Condition Assessment 2015-1380

For The Property Located At
3452 Hookstown Road, Beaver, PA 15061

The subject property in which a property condition assessment was completed is a commercial medical office building. It is a one story building on an approximate 1.54 acre site. It is owned by Valley Neurological. The Tax Parcel ID is 56-173 -0178.001.

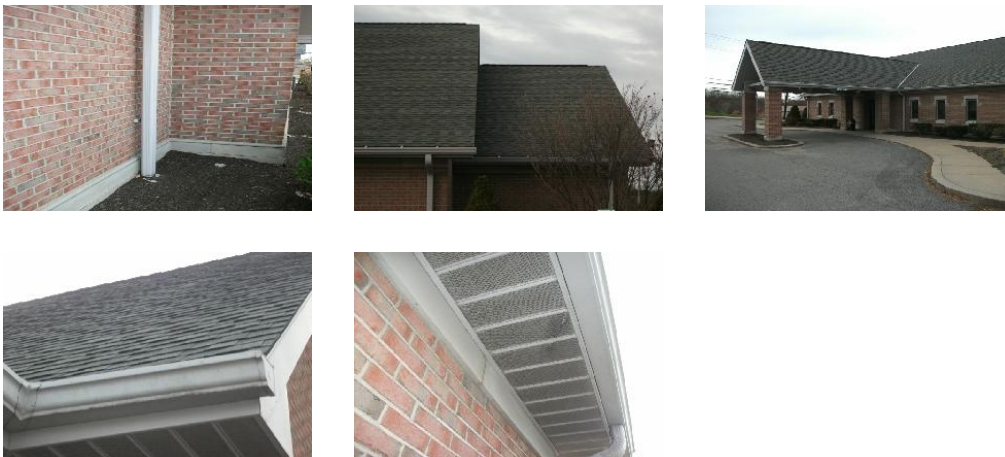
8.4 - MAINTENANCE: The roof gutters need to be cleaned and serviced to perform properly.

8.5 - GENERAL: The gutters and downspouts that were installed appeared to be in satisfactory condition.

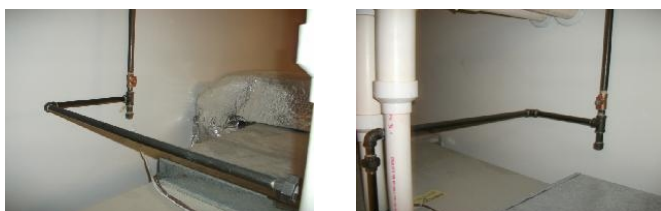
9.10 - GENERAL: Where visible, the gas supply system appears to be in satisfactory condition. The above ground gas supply system consists of black steel piping supply lines and approved gas cock valves.

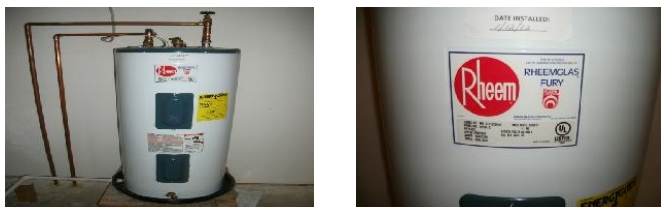
9.11 - GENERAL: There was 1 water heater(s) observed during the survey with the capacity of 30 gallons each. They were made by Rheem and other recognized manufacturers. The water heater(s) were located in the attic or in relationship to the fixtures they serve. The water heater observed is an electric powered unit.

9.12 - GENERAL: The domestic hot water heater was manufactured in April 2011 . It was placed in to service on January 12, 2012 .

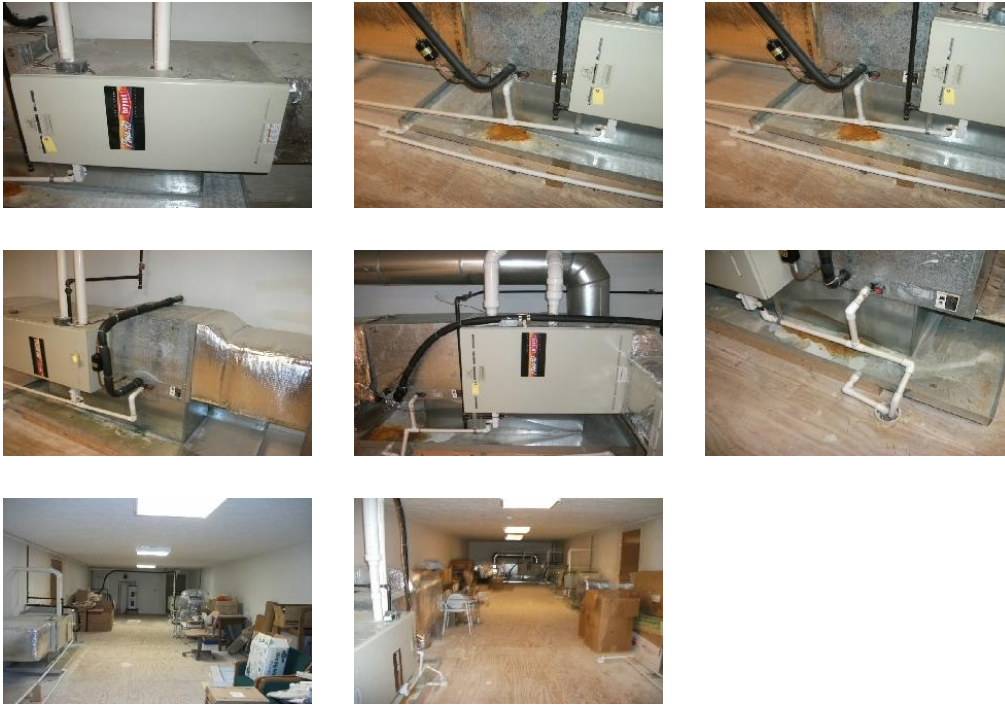
10.5 - COMMENTS: The 16 year old, 80,000 Btu BRYANT PLUS 90 gas-fired forced air heating unit(s) are located in the attic. . The number of furnaces present and in operation are five . The furnaces useful life is typically 15-20 years.

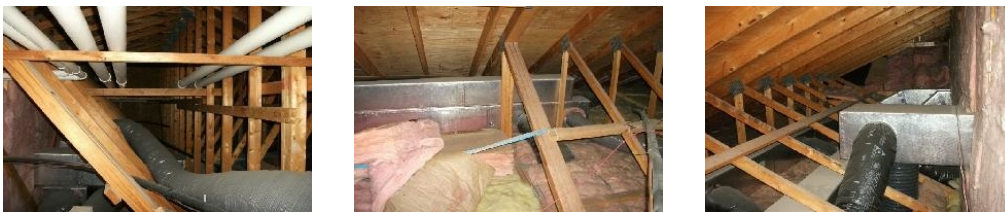
10.7 - GENERAL: Where visible and accessible, the flexible ducts and rigid distribution components supply ducts were in satisfactory condition.

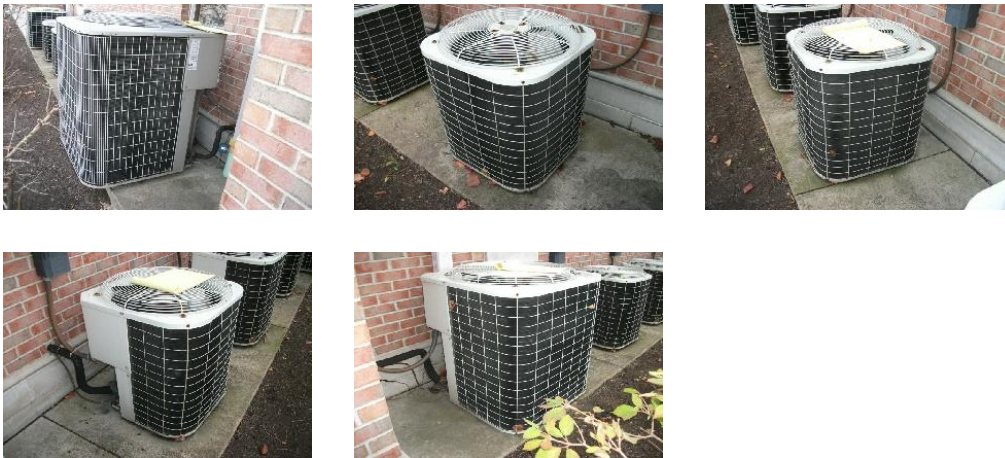
12.2 - GENERAL: Central cooling in the subject is provided by 5 , 16 year old condenser units on the exterior. There are two 5 ton BRYANT condenser units and three 3.5 tons Bryant units located at the east side of the building . They are on concrete pads.

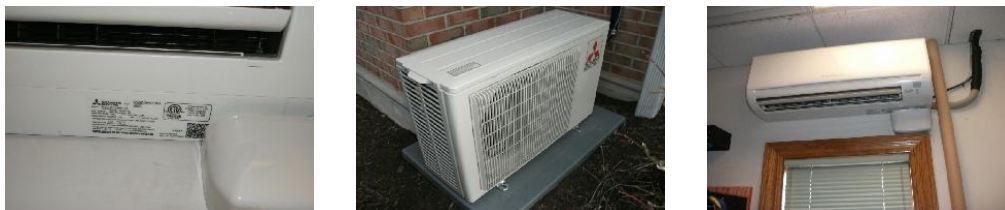
12.3 - GENERAL: The electrical room of the subject is also cooled separately by a Mistubishi Cooling Unit. It is located on the east side. It was installed in July 2015 approximately. This room houses the main electrical panel, telephone network, security system, fire alarm, and computer system for the office.

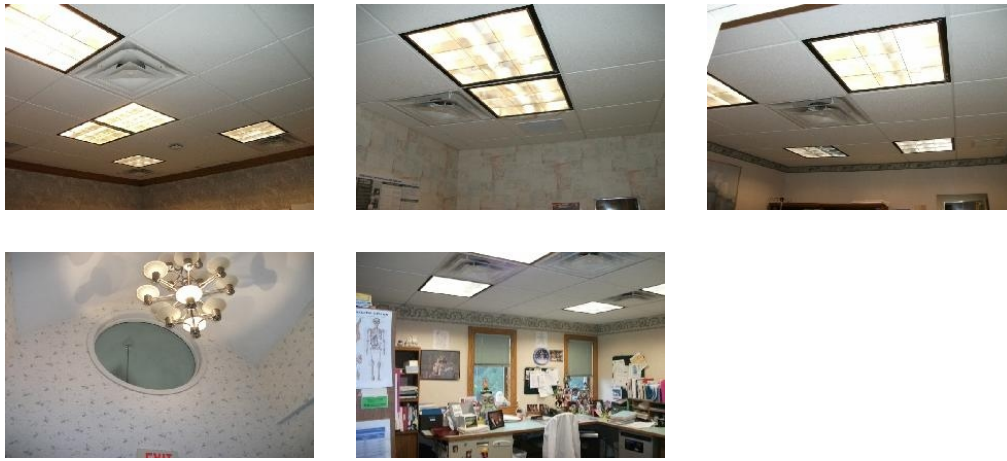
13.7 - GENERAL: Interior main lighting is provided with lay in fluorescent fixture adequately spaced throughout the building interior. There is a main light at the entrance which is a hanging fixture. No significant deficiencies were observed in intensity or coverage.

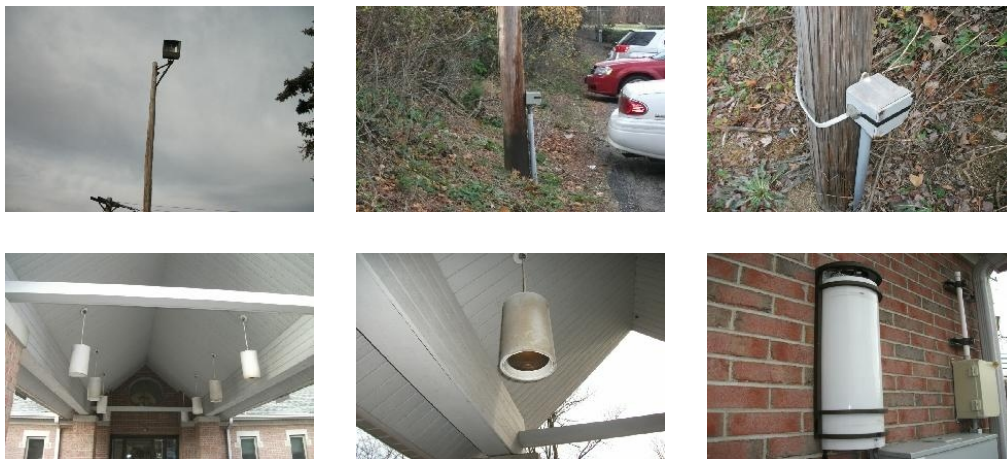
13.8 - GENERAL: Exterior lighting is provided by facade mounted fixtures and drop lights at the front entrance under the portico. The lights under the portico entrance are weathered. Some repairs or replacement may be required. The parking lot is lighted by lights on wooden telephone type poles. They are on their own timer control switch located in the electrical room.

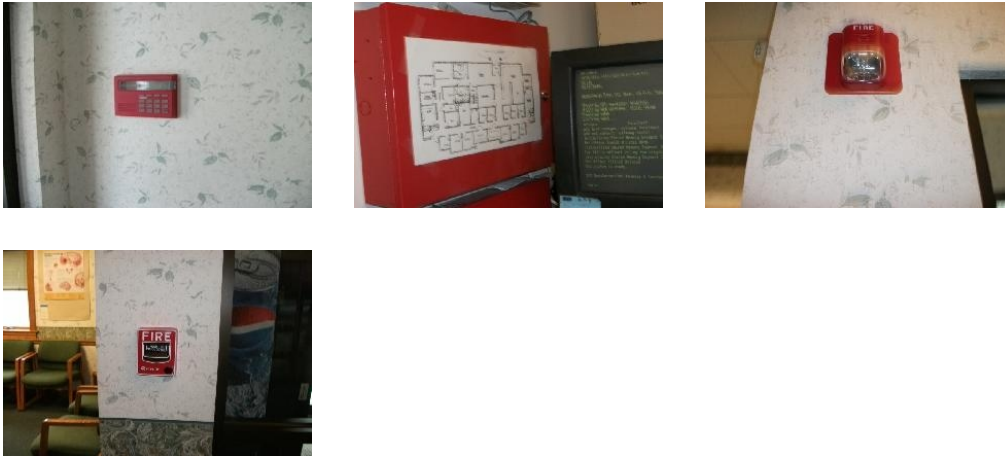
14.2 - GENERAL: A central fire alarm system is present at the subject property. The fire alarm system appears to offer full protection to subject property. It consists of alarm system, detectors, pull stations, and strobe assemblies.

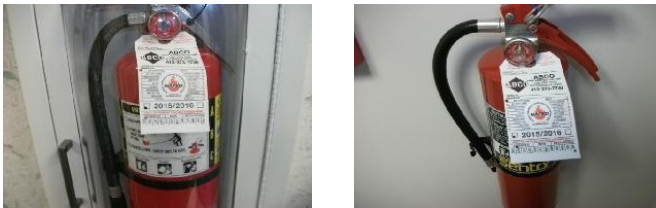
14.4 - GENERAL: The subject improvements appear to have adequate fire extinguishers present with current inspection tags. There are four fire extinguishers on site. They were serviced by ABCO Fire Protection Inc. of Pittsburgh PA on January of 2015 .

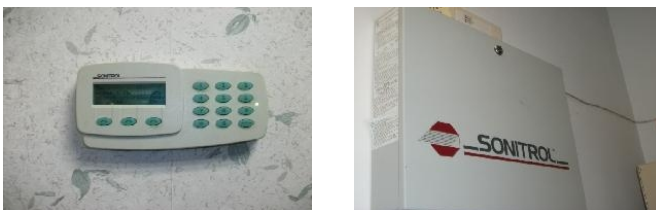
14.5 - GENERAL: The subject property is equipped with an electronic security alarm system with off site monitoring. The system is monitored by Sonitrol Systems .

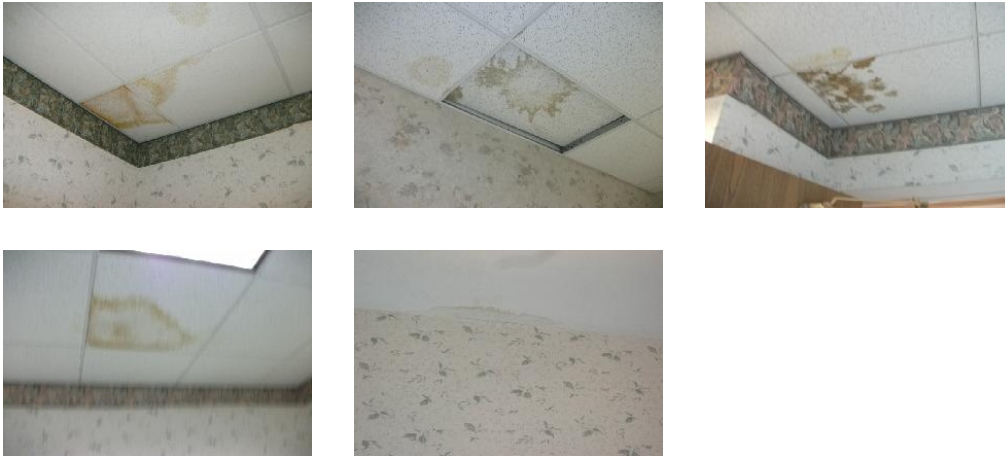
15.9 - MAINTENANCE: There are water stains or other evidence of moisture intrusion on some ceiling coverings that you will need to have evaluated if believed necessary. This is important because our inspection does not warrant or guarantee the roof against leakage. Please see Important Observations and Comments regarding Subject for more information.

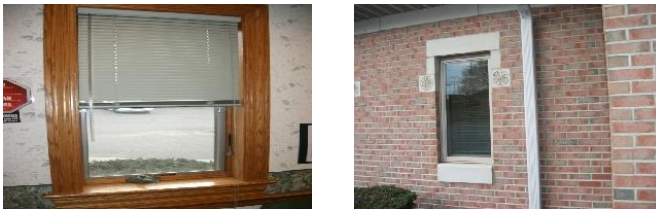
15.11 - GENERAL: The windows in this subject are predominantly aluminum and open to the exterior.

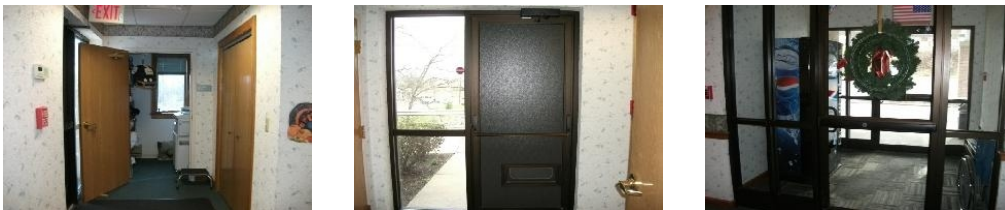
15.12 - GENERAL: The main entry door(s) and other exit doors are functional. They are aluminum and glass.

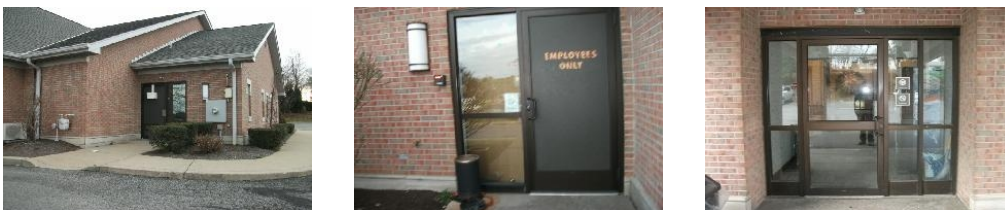
15.13 - GENERAL: The exterior doors function satisfactorily. The office manager reported that a rear door was replaced due to rusting out at the bottom. The cost was \$1500.00.
