Sample Commercial Property Inspection by Independent Property Inspection Consultants of Pittsburgh, PA 412-561-5969

Prepared For Exclusive Use By
John Q. Investor, Individual

For The Property Located At
67729 Long Run Road (Miller Automotive Garage), Valencia Park, PA 15044

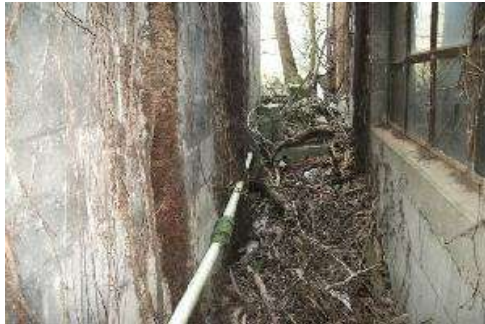
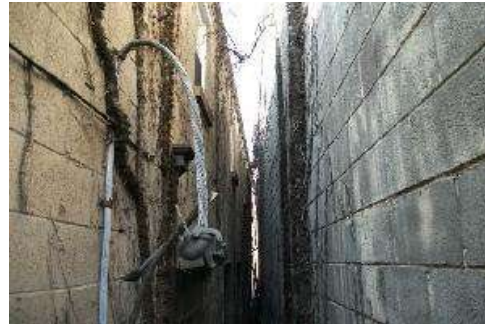
1.2 - MAINTENANCE: There is foliage growing on or against the west side of the garage that we recommend be removed or trimmed back to help prevent damage to the wall coverings. The debris in the area between the subject structure and the neighboring structure should be cleaned out and all vegetation.

1.3 - MAINTENANCE: There is a tree directly adjacent to the foundation at the west side of the garage that should be removed from the wall area and all growth removed garage west wall. Please see photos.

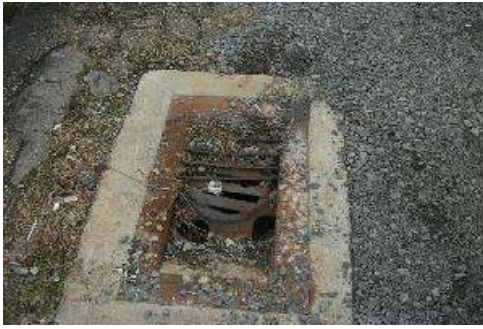
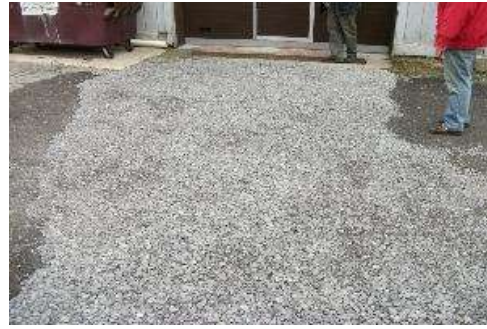
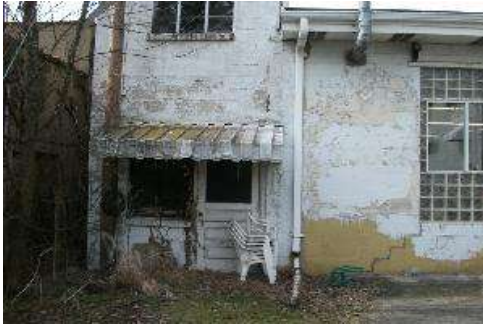
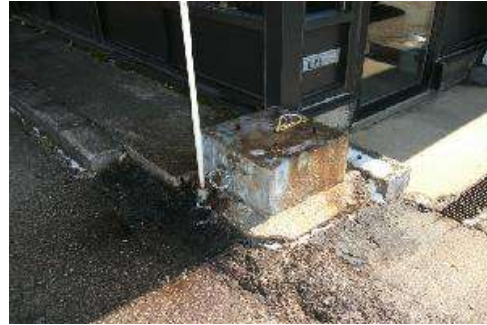
1.4 - DEFICIENT: There are potential trip hazards on the property which include the sunken surface drain outside the side entrance, the gravel driveway surface in the same area, rear exit door, and more possible unknown potential trip hazards. It is recommended that for safety reason that repairs be made to these items and that buyer review other exterior walking surfaces for potential problems.

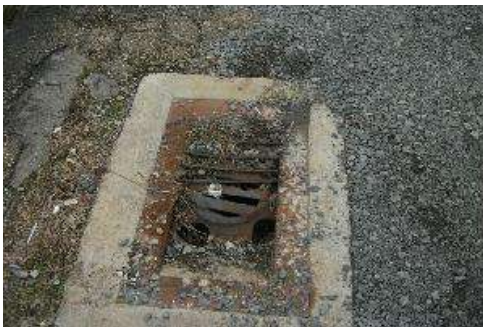
1.5 - DEFICIENT: There is a missing or broken area drain cover at the east side of the property. Since this condition may have allowed gravel, leaves, and other debris to enter the drain lines, it would be prudent to have the lines flushed through before the damaged cover is replaced or repaired.

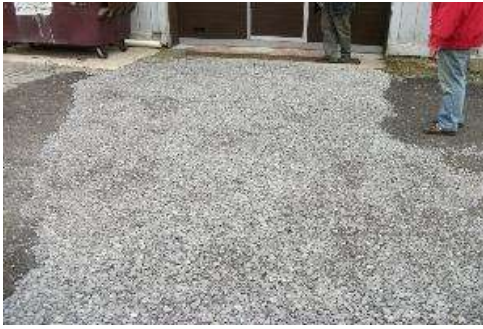
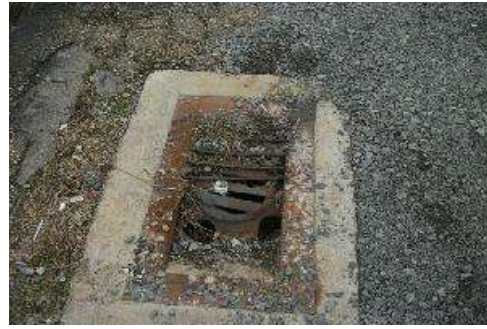
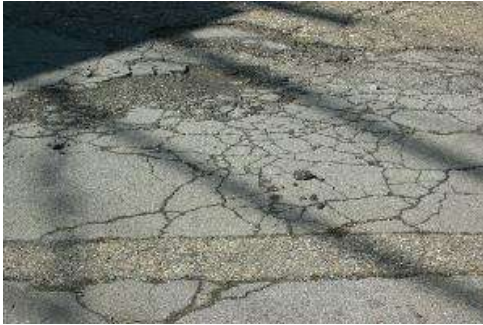
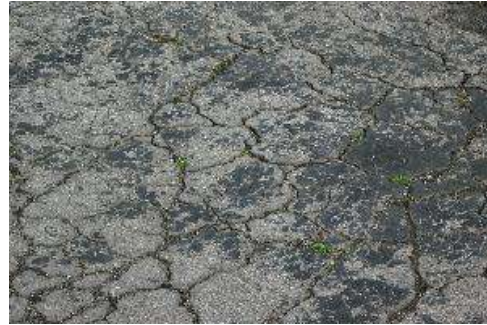
1.6 - DEFICIENT: Although functional, the asphalt driveway has not been maintained and is cracked and/or deteriorating in some areas. As a preventive measure, we recommend that all cracks be filled/sealed and that the driveway be re-coated or resurfaced to extend its life span. There are driveway areas which are gravel and needs resurfaced. **It is recommended that buyer obtain estimates from a qualified asphalt contractor for repairs to building driveway areas.**

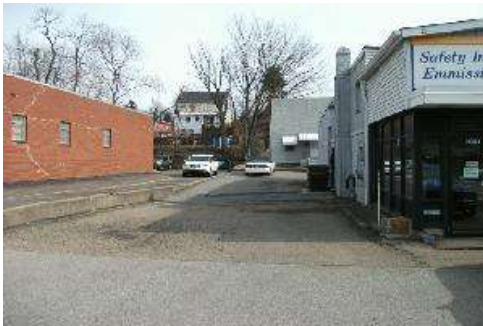
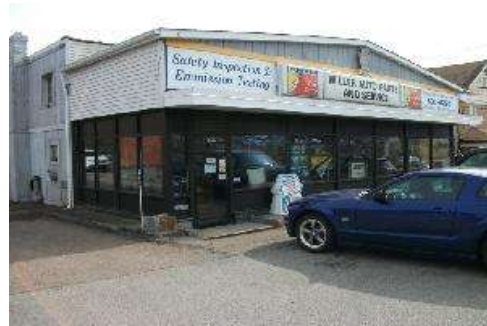
1.7 - DEFICIENT: The asphalt driveway is functional but has some cracks and areas needing repairs.

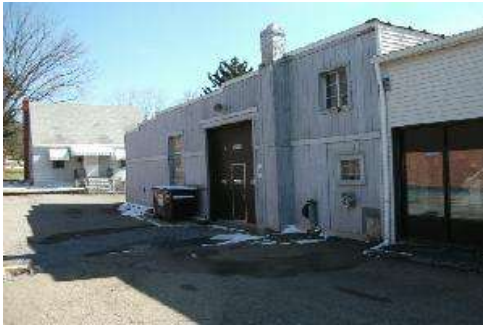
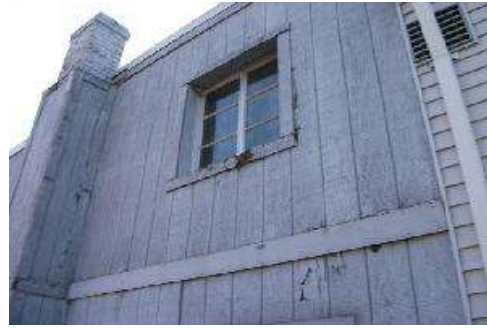
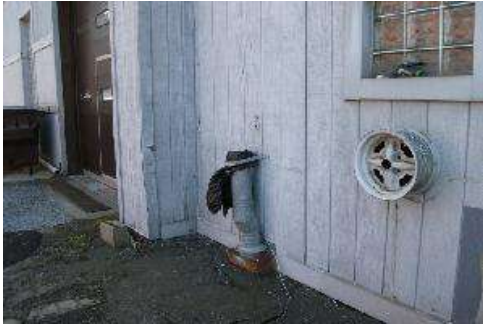
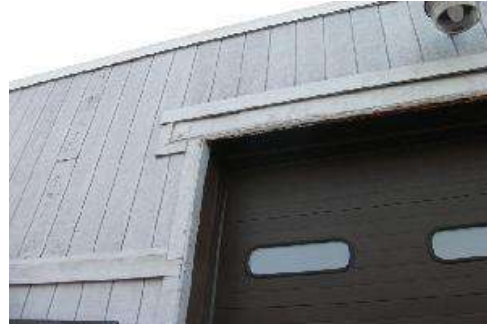
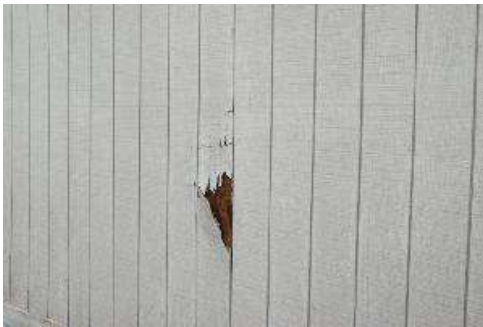
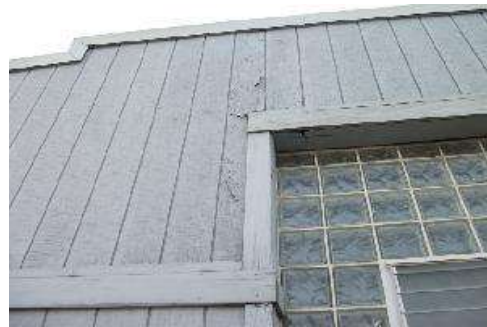
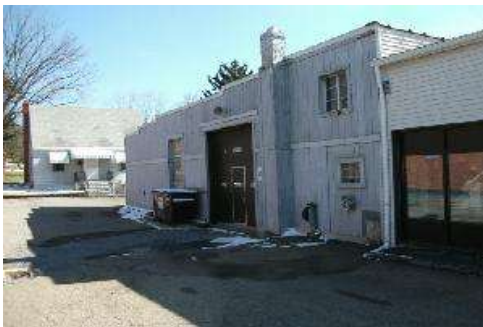
1.8 - DEFICIENT: There is moisture damage at the base of the composition wood wall covering at the east side of the garage that needs to be repaired.

1.9 - DEFICIENT: The composition wood wall coverings at the the east side of the garage is damaged and repairs needed. The wall coverings are in poor condition with holes, open joints, deteriorated wood, rot, and separation in some areas. Repairs or removal to these coverings are needed. The owner indicated it was installed to provide some insulation to the building. It is recommended to obtain estimates for its repairs or removal. Please see doors and windows for information on the garage door steel lintel which has deterioration.

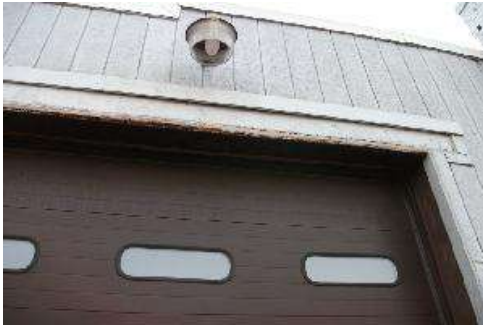
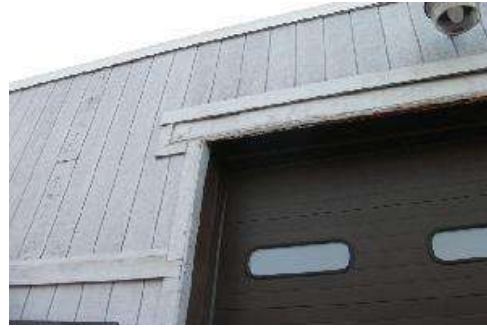
1.10 - DEFICIENT: The metal steel lintel above main vehicle garage door which supports the concrete block wall above it is rusted and sagging. It is fatigued. This was caused by water leaking on the wall on to the lintel and not being able to weep out. It is unclear as to the condition of the block wall above due to the wood siding installed over it. This lintel must be kept in good shape and after repair of siding should be inspected and repaired. The current lintel may still be sufficient condition to be utilized with caulking and sealant removed.

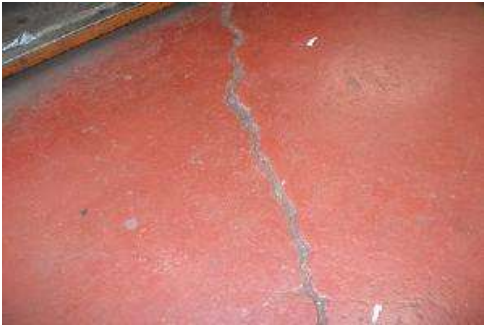
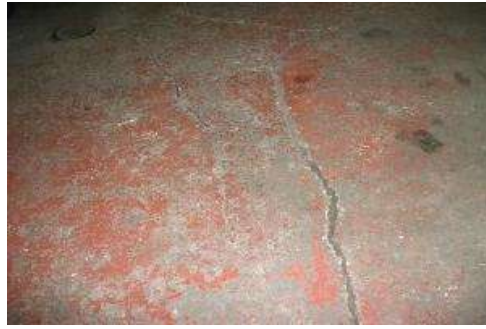
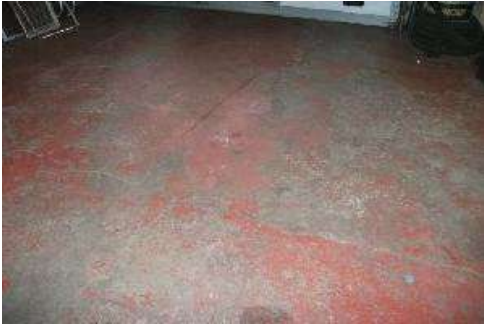
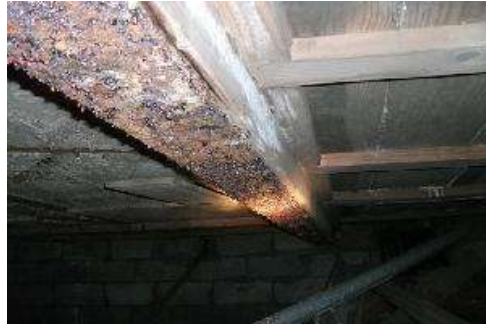
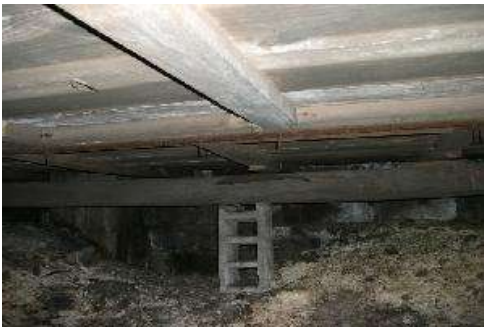
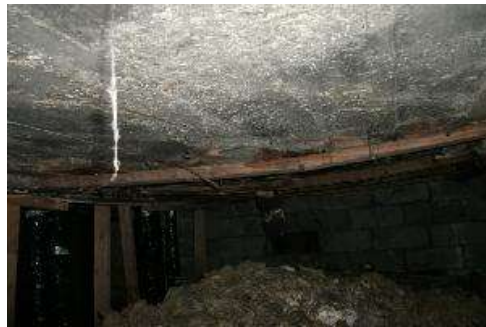
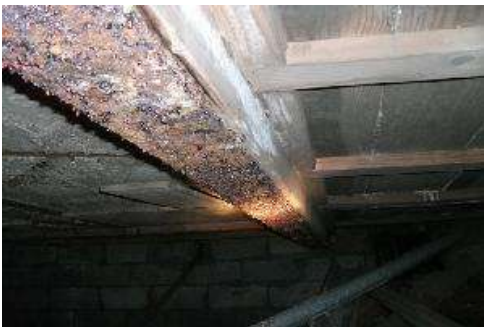
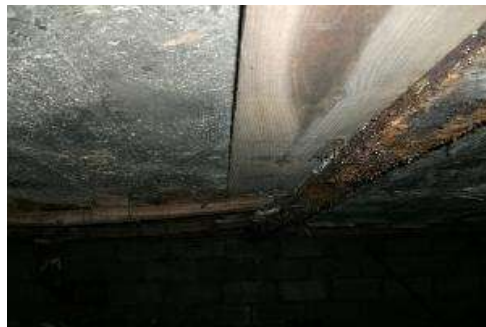
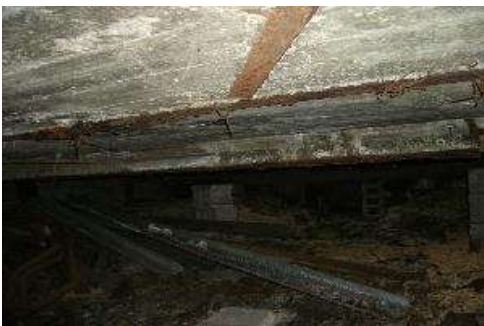
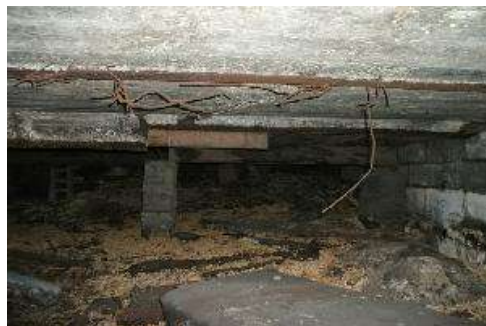
2.1 - DEFICIENT: The condition of the garage floors from the garage show a number of cracks. Please see photos. From this perspective it appears typical considering the age of the structure and garage which I understand was built in the 1940's or maybe earlier. The inspection from the crawlspace under neath show structural conditions that are likely ongoing due to the metal fatigue of the some structural supports. The owner indicated he has done no repairs to the floor during his use of the building which he inherited from his father. The inspection indicated substantial repairs on this crawlspace section on east side of the building. The wood framing installed to support the poured concrete appears more of more recent nature than the 1940's the owner indicated. I can not confirm this completely. This part appears in good condition. Please see two photos showing framing. The center of the crawlspace area under the floor indicate repairs completed which if completed at the time the owner indicated would show that there is on-going deterioration of the steel support beams. If you review the photos attached you will notice that the original framing installed years ago is now bowed meaning the deterioration of the steel "I" beams support is weakening forcing the bowing in the wood frame installed years ago or at some point. **These areas will likely be points of repairs in the future. The steel beams are heavily rusted, fatigued, and show movement.** The repairs may not be in near future but are evidence of repairs regardless of when they were done. There are other areas which were blocked up for repairs, again it is unclear what period of time this was. In summary, no guarantee can be given as to when any floor repairs will be required. The repairs can be in sections at the point of failure which will required new steel framing and floor replacment. The cost cannot be estimated at this time. The accompanying photos show the latest lift installation in the crawlspace. The existing conditions may provide continued service for unknown periods. I do not believe any floor failure will be wholesale and warning signs should show indicating immediate repairs. It is recommended to

monitor floor conditons for any new developments. A budget should be available for capital repairs and improvements.

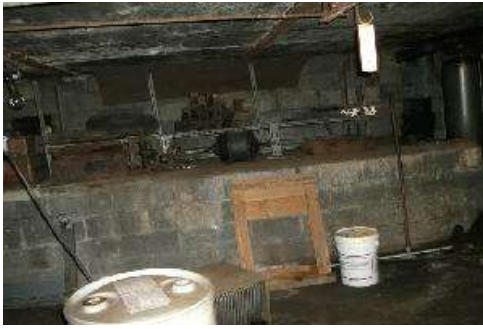
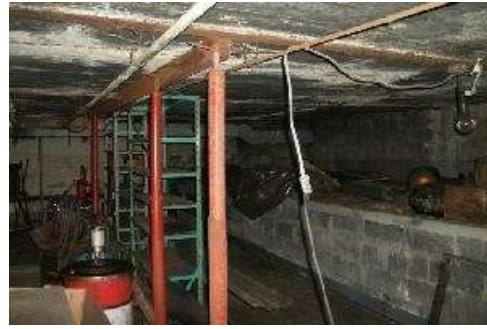
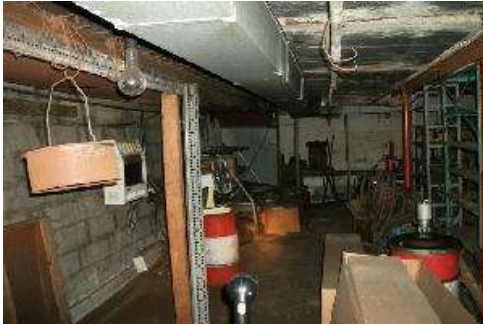
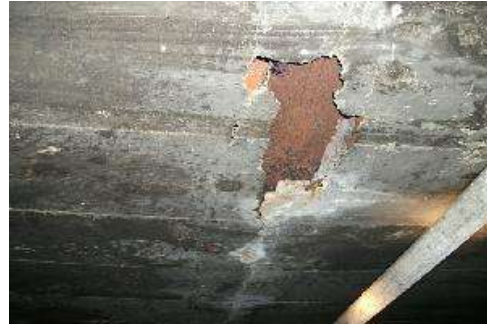
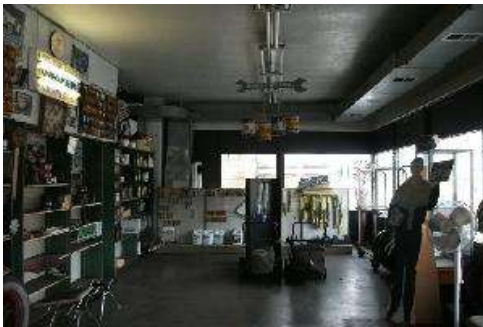
2.2 - DEFERRED: The floor of the garage and showroom is constructed of poured concrete. The inspection of the concrete floor from the basement indicate evidence of floor deterioration. structural "I" beam deterioration from moisture and dampness, and signs of temporary repairs of the above show room floor. The inspection of the floor above is limited due to furniture, shelving, etc. The structural steel supports show heavy rust deterioration. It is recommended that improved ventilation be installed including heat, flooring repair if needed, and rust proofing be applied to steel components to slow deterioration. In the event that a small section of concrete flooring needs to be completed the repair cost should be minimal. The age of the building is 70 plus years and the conditions typical considering prior and current use, prior water penetrations, lack of ventilation, and minimal maintenance. Considering the overall poor condition of area, long term it is typical for a garage. The basement area does not appear to be under the entire showroom area.

2.3 - DEFERRED: There are components of the raised foundation concrete floor structure that appear to be structurally unsound and/or represent a potential hazard and should be evaluated by an appropriately qualified specialist for further remarks and recommendations. A structural engineer is considered best qualified.

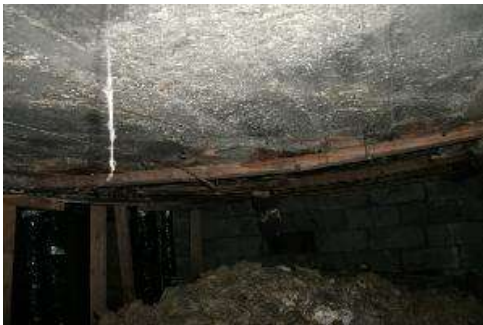
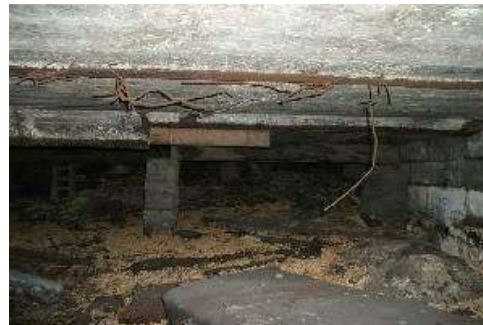
2.7 - DEFICIENT: The crawlspace under the garage floor and lower basement is substandard. This condition can and has deteriorated the steel framing and support components. It is recommended that a source of heat be placed in the basement and crawlspace from a forced air furnace. Since the garage was built in the 1940's it is relatively in good condition. Natural ventilation improvements if possible are recommended.

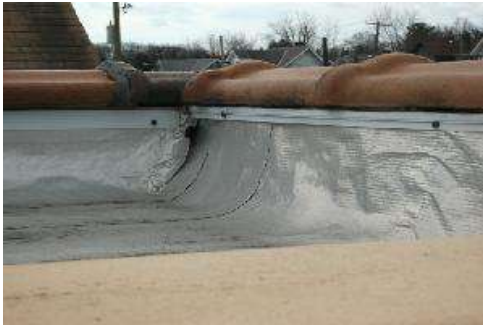
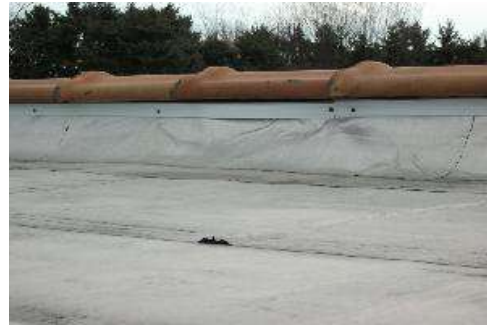
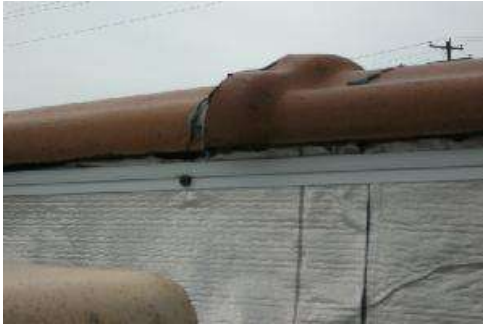
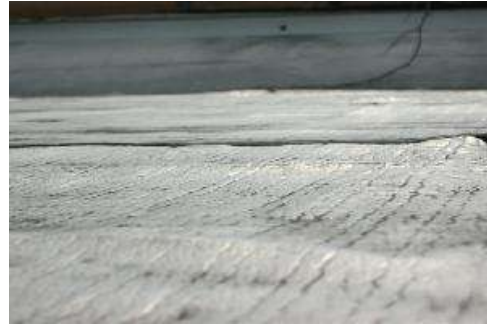
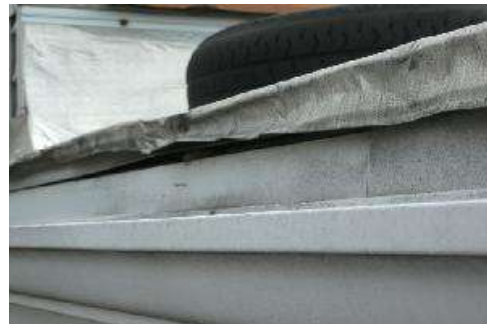
3.1 - MONITOR: The upper west side roof covering appears to be an ice guard material. I am not completely familiar with this particular type but it appears it was installed by a non professional as it has open seams, various methods of attachments, and other signs non professional workmanship. There is no signs of leakage. There is minor typical damage to the over hang portions of the roof. It is recommended to monitor the roof and seal any open joints with similar materials if possible. Please see the photos.

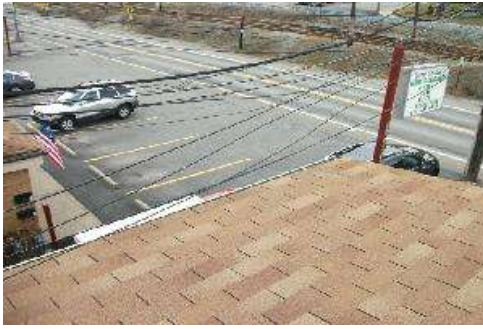
3.2 - COMMENTS: The garage has a sloped or pitched roof. Most sloped roofs are covered with individual pieces of shingle or tile material that is overlapped to prevent water penetration. The slope of a roof is usually a factor in the life expectancy of the roofing material. The life expectancy of a roof covering is also dependent upon the type of material used, the quality of workmanship, exposure to sun and wear from tree branches, snow or ice, and wind. Asphalt shingle is the most common roofing material used on sloped or pitched roofs. Other types of covering for sloped roofs include asphalt roll roofing, concrete or clay tiles, wood shakes and shingles, and slate shingles. There are also fiberglass shingles, metal shingles and metal sheet roofing systems.

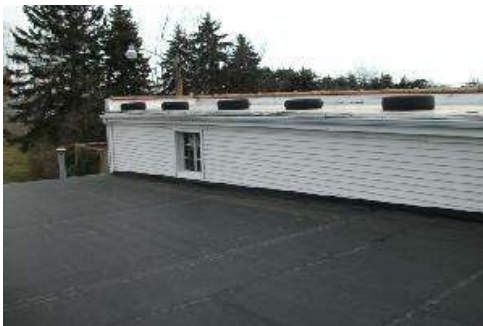
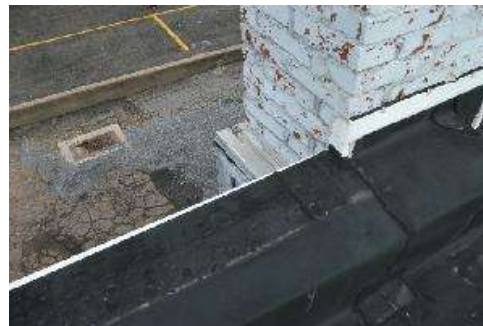
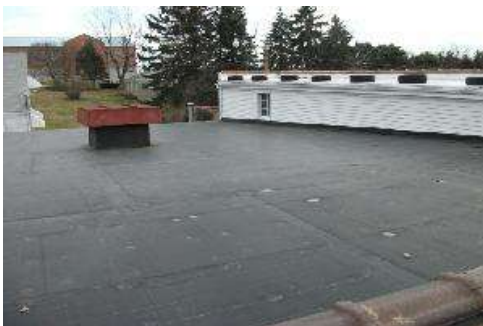
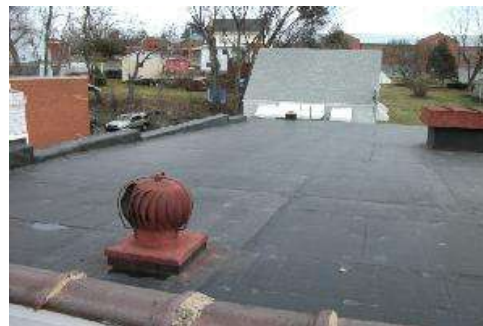
3.3 - COMMENTS: The garage has what is commonly referred to as a 'flat' roof. Flat roofs are basically watertight membranes that should have just enough slope to allow water to run off. The slope of the roof is usually a factor in the life expectancy of the roofing material. The life expectancy of a roof covering is also dependent upon the type of material used, the quality of workmanship, exposure to sun and wear from tree branches, snow or ice, and wind. Flat roofs must be regularly maintained and routinely repaired for damages.

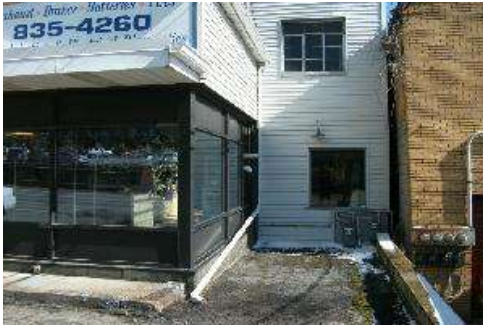
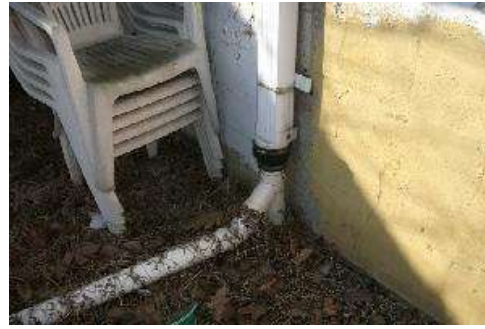
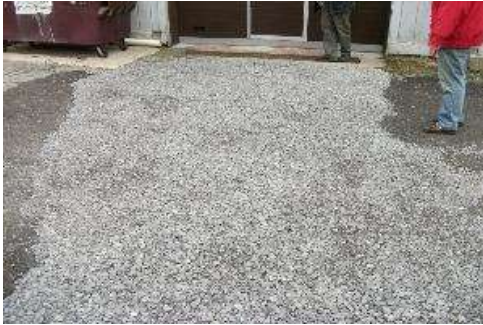
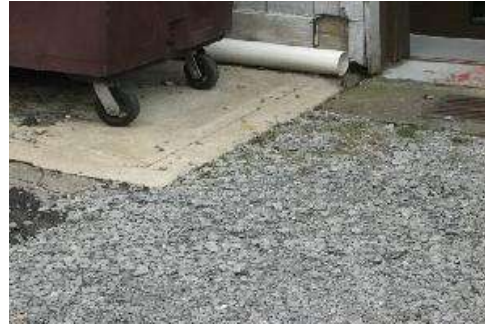
3.6 - DEFICIENT: Some downspouts are missing or need to be reconnected or serviced. The inspection revealed that downspout is missing on front of building and the roof drain line coming from rear of building along the side in to the garage door surface drainage ground reservoir. The rear downspout near the door indicates discharge on to ground from connection to underground leader. It is unclear if this leader is sealed, clogged, or in service. It appear it is clogged and the diverter installed to empty on to ground if clogged or restricted. Repairs may be required. The Brough of Bethel Park may require a dye test of all of these components for property transfer.

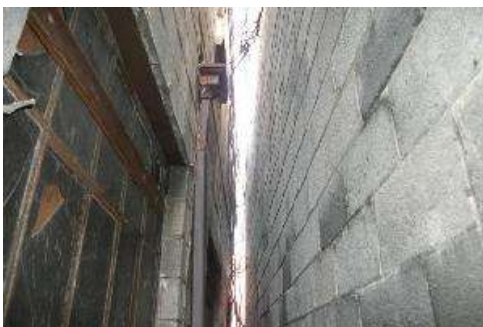
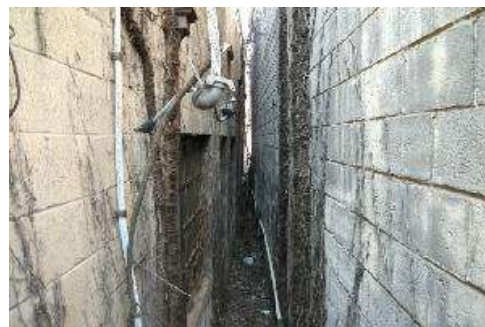
3.10 - COMMENTS: The failure of the adjoining property owner to maintain his property between the subject building and his building may affect the foundation and structure due to the neighbor not maintaining his gutters and water discharge. You may want to review this area.

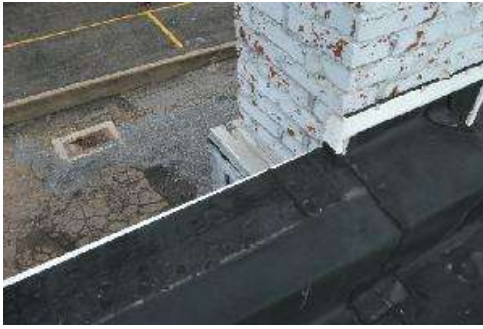
3.11 - MAINTENANCE: The tops of the parapet walls need minor sealing. The conditions are typical. In general most contractors when they run the roof covering over the parapet walls they install an aluminum flashing cap. This was not done and can be done. There is no immediate need and this is for information purposes. Please see photo for illustration. There are some looseness in some parapet wall caps which can be cemented.

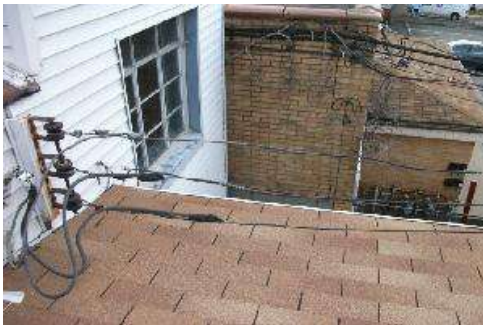
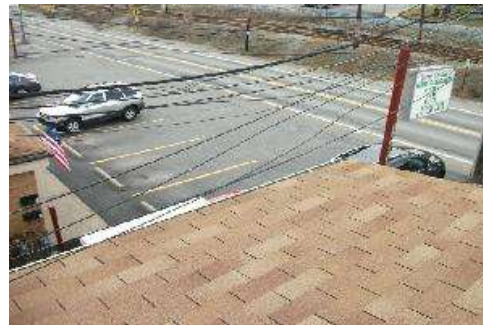
4.2 - DEFICIENT: The utility companys overhead conductor lines over the roof ridge are too low and need to be raised by the utility company for safety and by your contractor for installation of a raised mast head. The roof clearances are not per the National Electrical Code and are considered unsafe. The conductors should have insulation added to them for additional protection. **THIS WORK MUST BE COMPLETED BY QUALIFIED AND TRAINED INDIVIDUALS ONLY.**

4.3 - SAFETY: The overhead conductor lines to the garage are too low and need to be raised by the utility company.

4.4 - SAFETY: The utility companys overhead conductor lines are missing insulation and need to be replaced for safety due to present location.

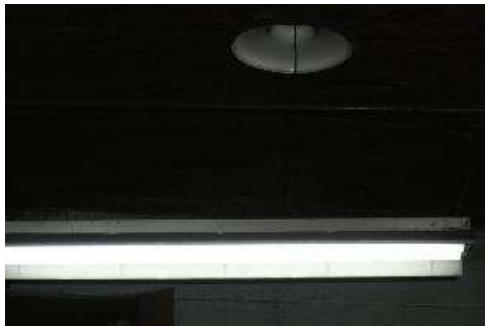
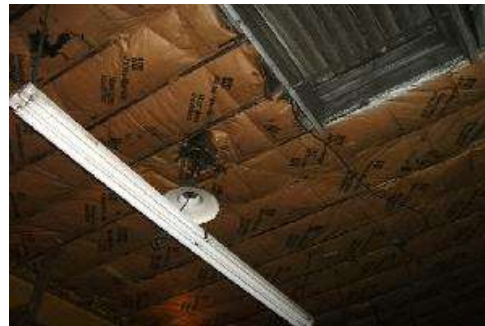
4.11 - PREVENTIVE: The fluorescent ceiling light fixtures in the garage should be evaluated for proper wiring connections. They appear to be fed by the old light fixtures. If they need corrected appropriate repairs should be made.

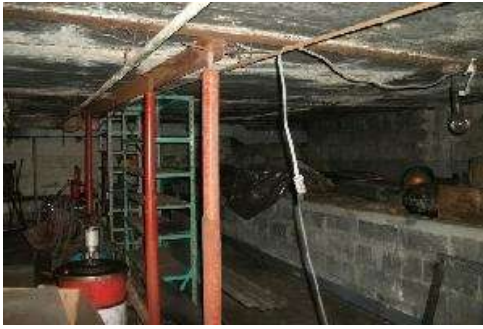
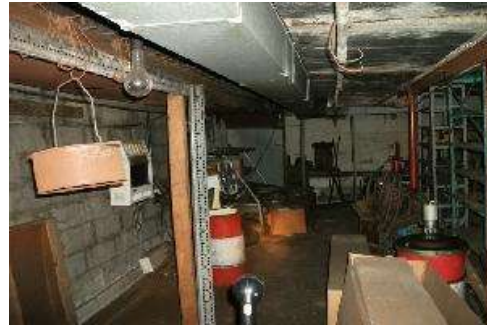
4.12 - DEFICIENT: **The basement wiring and lights in the garage are old, rusted, broken, damaged, and in need of repairs. It is recommended that a qualified electrical contractor be contacted to evaluate building electrical and make repairs to any areas including the basement lighting and outlets.**

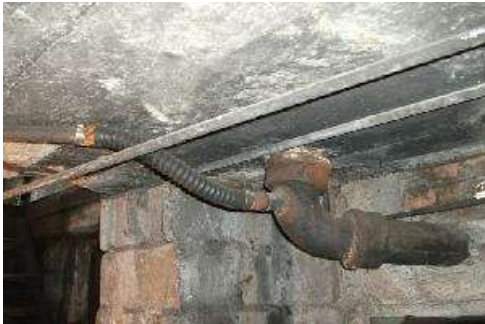
5.6 - DEFICIENT: The drainage line for the bathroom sink is of non approved materials. Please contact licensed plumber to install materials on drain line system. Please see attached photo.

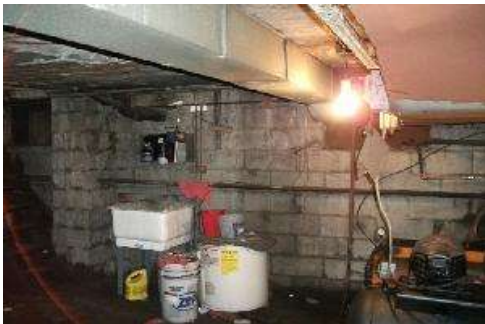
5.7 - DEFICIENT: **The fixture drain on the basement sink was not properly installed and vented. Please contact a licensed plumber to repair in accordance with local code requirements or to move the sink to another location. The current sink is draining on to the floor surface drain.**

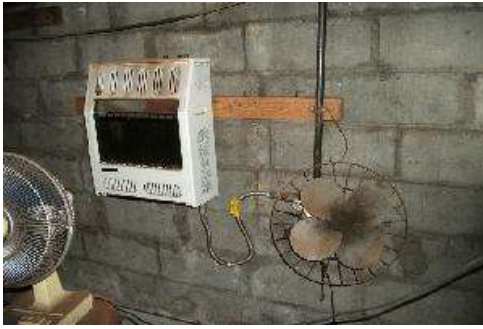
6.8 - COMMENTS: The basement is heated with a gas-fired gas wall heating unit is located in the basement. on the north wall. This system is minimal and just enough to prevent pipes from freezing. This system was operational on day of inspection. It is one of three systems in use in the garage building. The combination is inefficient. It is recommended you obtain copies of of past gas usage to determine budget costs.

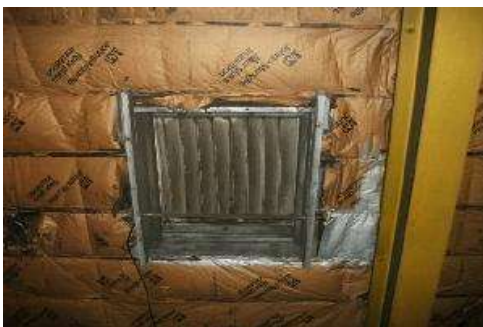
7.2 - DEFICIENT: **The roof mount exhaust system for the garage to remove carbon monoxide gases, vehicle exhaust, and garage odors is not functional according to the owner on the day of inspection. He indicated he tried to repair it but the motor does not work. This item should be checked and repaired as required for proper operation. It is a part of the building operating system and it is a part of normal garage operations. The local inspector may require additional safety equipment and ventilation improvements. This item is deficient until made operational and in good condition. Please call a qualified mechanical ventilation contractor to repair.**

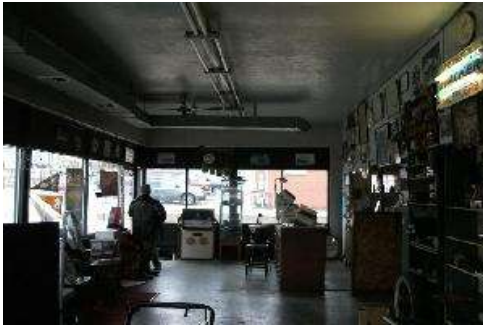
7.3 - SAFETY: The installation of emergency lights and lighted exit signs is a common requirement for safety of the occupants under the building code. Their installation may be a requirement for occupancy. If they are not they are highly recommended. The lights are required to cover all areas and the exits signs are required for all areas along the egress path. **The purchaser is advised to obtain estimates for the installation of emergency lights and exits signs for the safety of occupants and customers as well as meet compliance for building code requirements and insurance purpose's.**

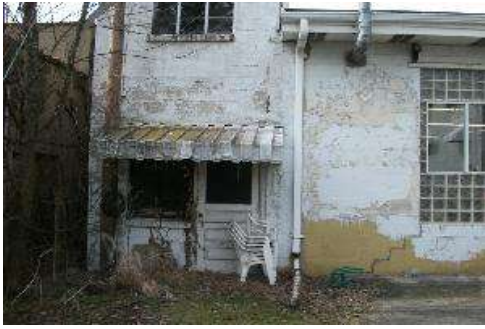
8.2 - MAINTENANCE: There is moisture damage or decay at the garage rear egress door which may require repairs.
