Sample Commercial Property Inspection by Independent Property Inspection Consultants of Pittsburgh, PA 412-561-5969

Prepared For Exclusive Use By
John Q. Investor, Individual

For The Property Located At
67729 Long Run Road (Miller Automotive Garage), Valencia Park, PA 15044

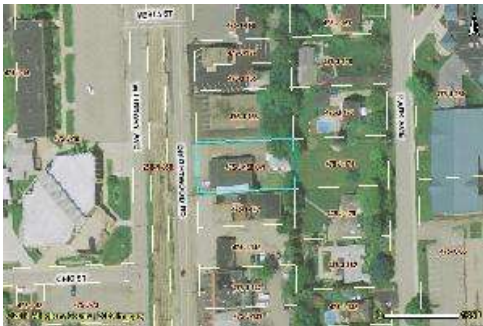
1.11 - COMMENTS: The aerial view of the inspected property is in the attached photo. It is provided for information to the client.

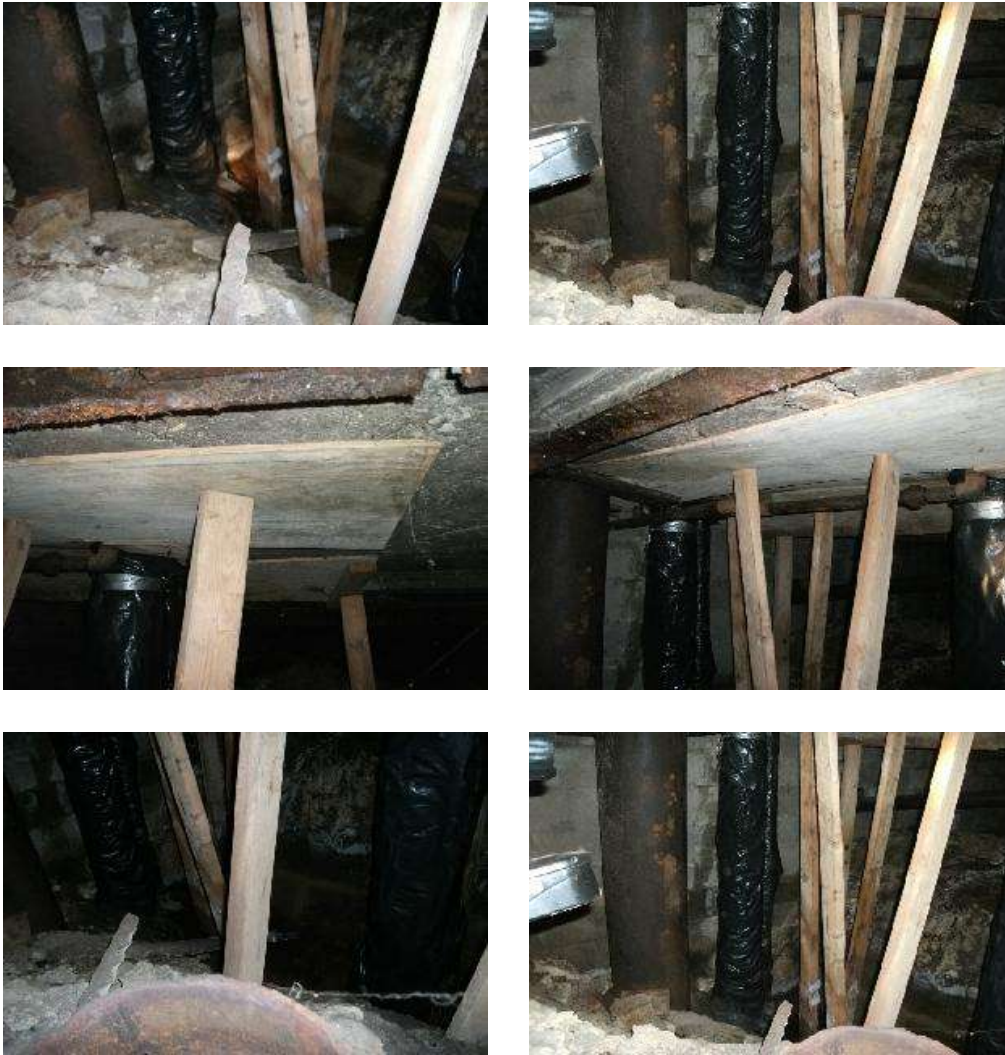
2.2 - DEFERRED: The floor of the garage and showroom is constructed of poured concrete. The inspection of the concrete floor from the basement indicate evidence of floor deterioration. structural "I" beam deterioration from moisture and dampness, and signs of temporary repairs of the above show room floor. The inspection of the floor above is limited due to furniture, shelving, etc. The structural steel supports show heavy rust deterioration. It is recommended that improved ventilation be installed including heat, flooring repair if needed, and rust proofing be applied to steel components to slow deterioration. In the event that a small section of concrete flooring needs to be completed the repair cost should be minimal. The age of the building is 70 plus years and the conditions typical considering prior and current use, prior water penetrations, lack of ventilation, and minimal maintenance. Considering the overall poor condition of area, long term it is typical for a garage. The basement area does not appear to be under the entire showroom area.

2.3 - DEFERRED: There are components of the raised foundation concrete floor structure that appear to be structurally unsound and/or represent a potential hazard and should be evaluated by an appropriately qualified specialist for further remarks and recommendations. A structural engineer is considered best qualified.

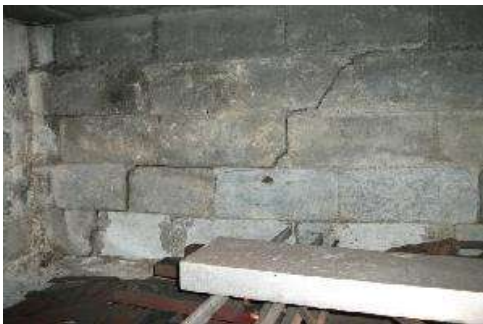
2.4 - COMMENTS: The concrete block foundation walls where visible appear to be functional. Typical crack observed.

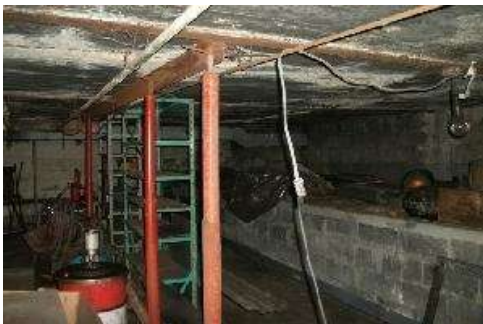
2.7 - DEFICIENT: The crawlspace under the garage floor and lower basement is substandard. This condition can and has deteriorated the steel framing and support components. It is recommended that a source of heat be placed in the basement and crawlspace from a forced air furnace. Since the garage was built in the 1940's it is relatively in good condition. Natural ventilation improvements if possible are recommended.

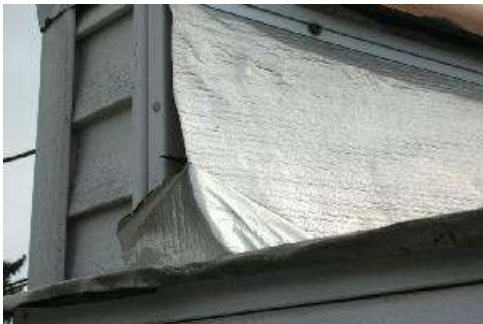
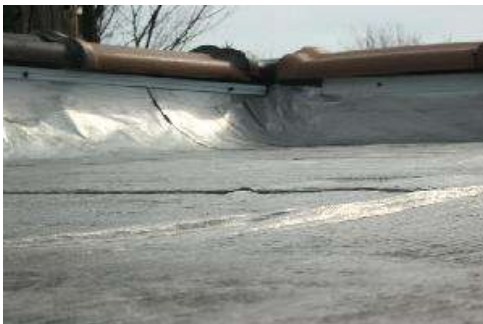
3.1 - MONITOR: The upper west side roof covering appears to be an ice guard material. I am not completely familiar with this particular type but it appears it was installed by a non professional as it has open seams, various methods of attachments, and other signs non professional workmanship. There is no signs of leakage. There is minor typical damage to the over hang portions of the roof. It is recommended to monitor the roof and seal any open joints with similar materials if possible. Please see the photos.

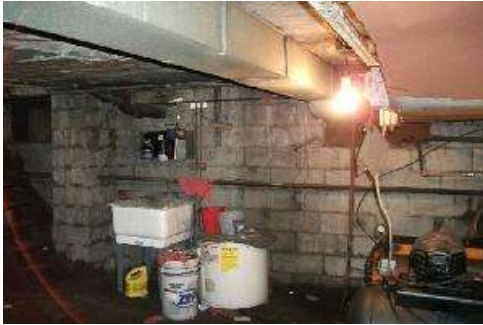
4.12 - DEFICIENT: **The basement wiring and lights in the garage are old, rusted, broken, damaged, and in need of repairs. It is recommended that a qualified electrical contractor be contacted to evaluate building electrical and make repairs to any areas including the basement lighting and outlets.**

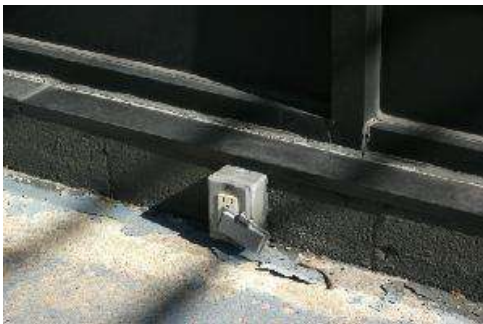
4.14 - DEFICIENT: The GFCI protected receptacle outlet at the north exterior will need checked for proper operation and a new cover approved cover installed.

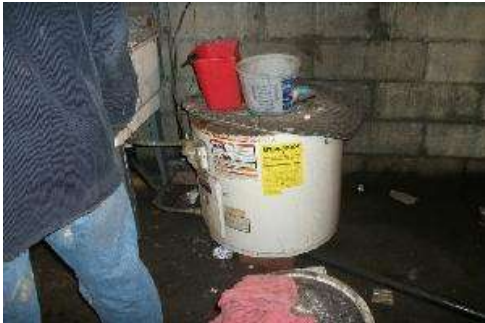
5.11 - MONITOR: There is a an electric water heater located under the show room area in the basement lower level. The client indicated it was working on Sunday February 26, 2012. The heater only serves the utility tray in this lower level basement area. It does not serve the sink in the unisex bathroom above it where no hot water is available. These heaters usually have a five year life cycle.

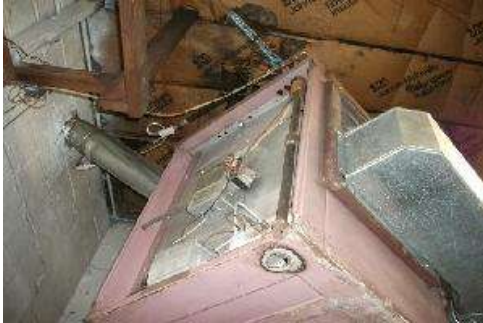
6.2 - DEFERRED: The garage force air space heater responded to the controls. The condition of the system appears poor. It likely has not been serviced in a recent period. These are space heaters whose adequacy is not evaluated during this type of inspection and time. The photo of the units is indicative of its condition. Its remaining life is year to year. This heater has been modified to force air into the backroom or storage area. It is a sign that heating and distribution in the building overall is marginal and not fully designed. The review of past heating bills should be conducted and funds budgeted for improvements in the building heating system.

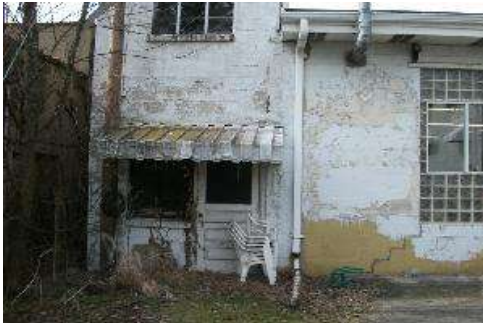
7.4 - COMMENTS: There are some windows which need property maintenance.

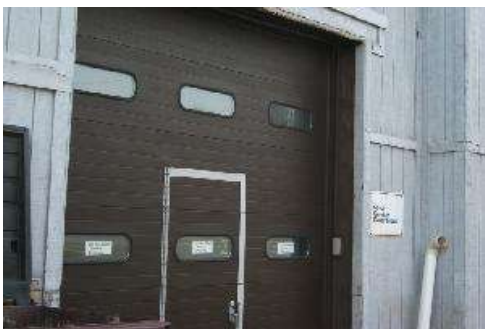
8.3 - COMMENTS: The garage vehicle door functioned satisfactorily when tested using the automatic opener.
